## Brick House on the Pike (Brick House Farm, Ellerslie)

### **Architectural Survey File**

National Register of Historic Places  
Registration Form

historic name BRICK HOUSE ON THE PIKE (preferred)

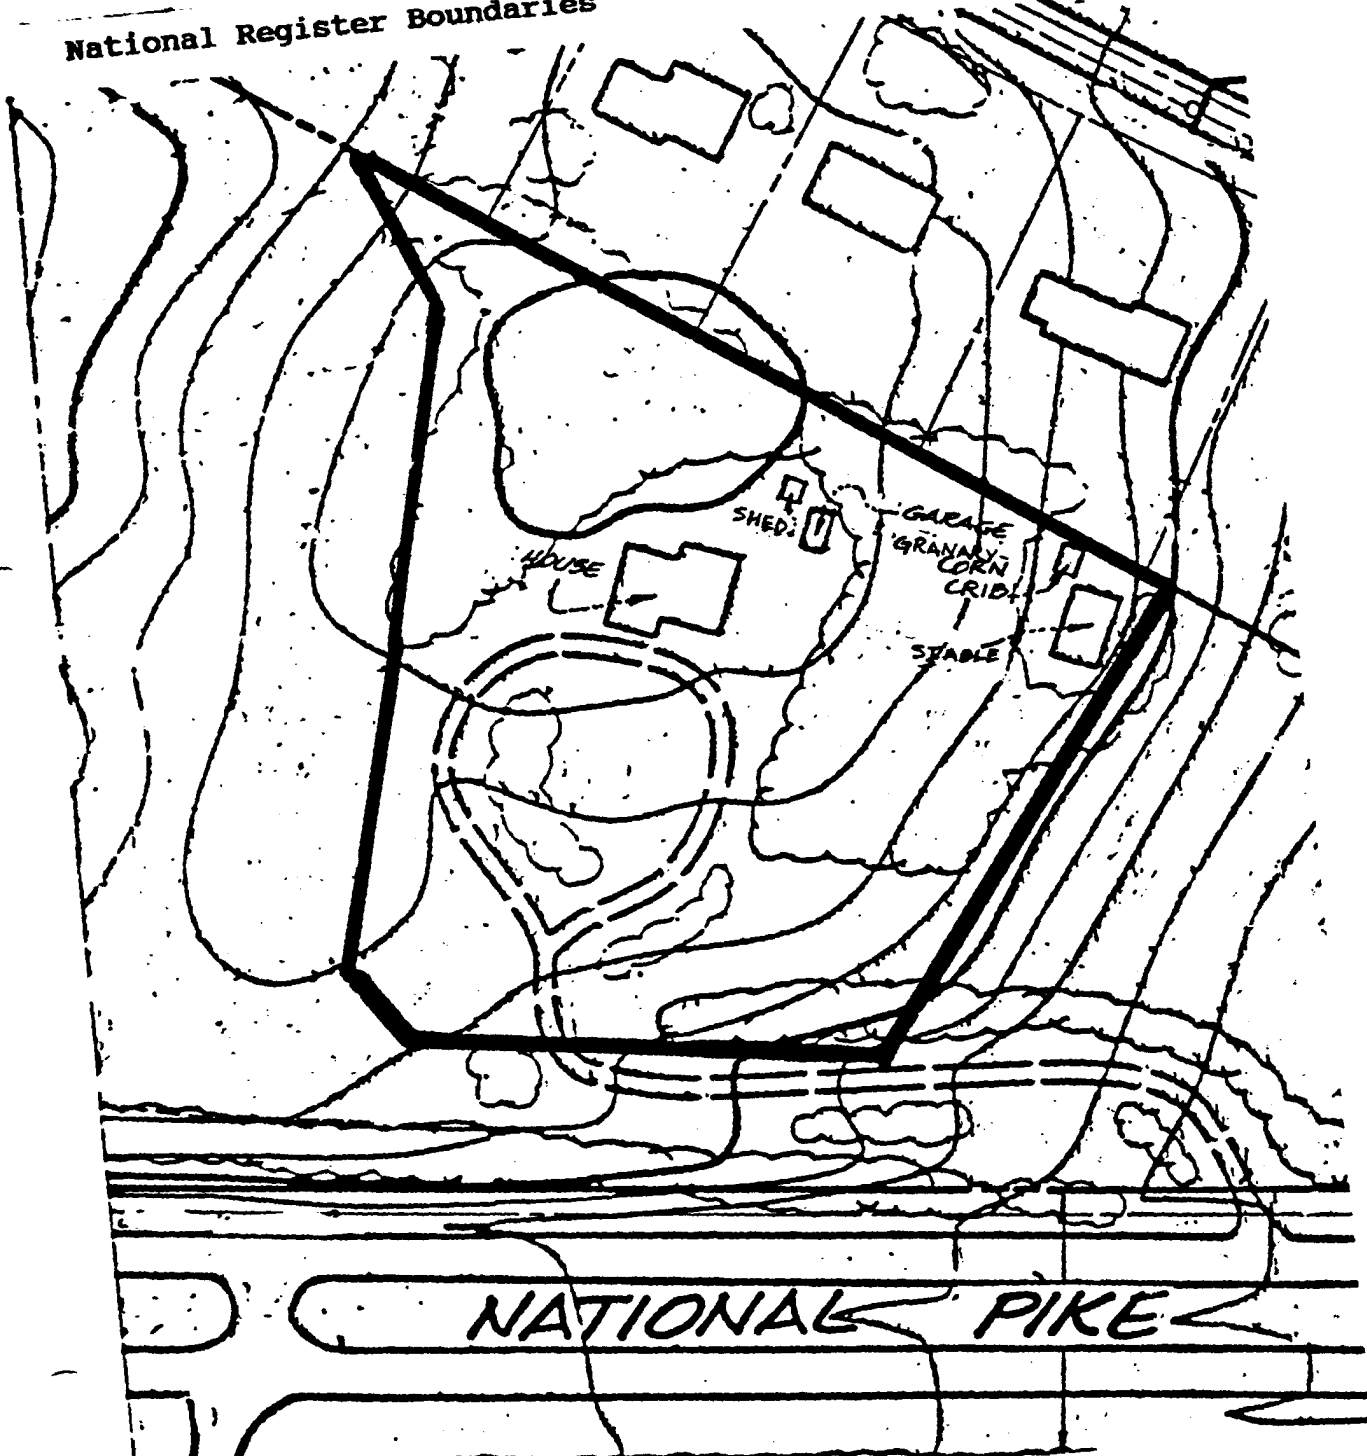
National Register Boundaries

The boundary of the nominated property is shown as the heavy solid line on the accompanying map entitled "National Register Boundaries", dated September 1994 and drawn to a scale of 1"=100'.

The nominated property includes the landscaped domestic yard surrounding the house, representing the remnant of the parcel historically associated with the resource which has retained integrity. The boundaries include the house and outbuildings within their historic setting. Existing and planned residential development lies beyond the western and northern boundaries. To the east and south of the nominated property lies undeveloped wooded space; abrupt changes in topography also serve to define the east and south boundaries.

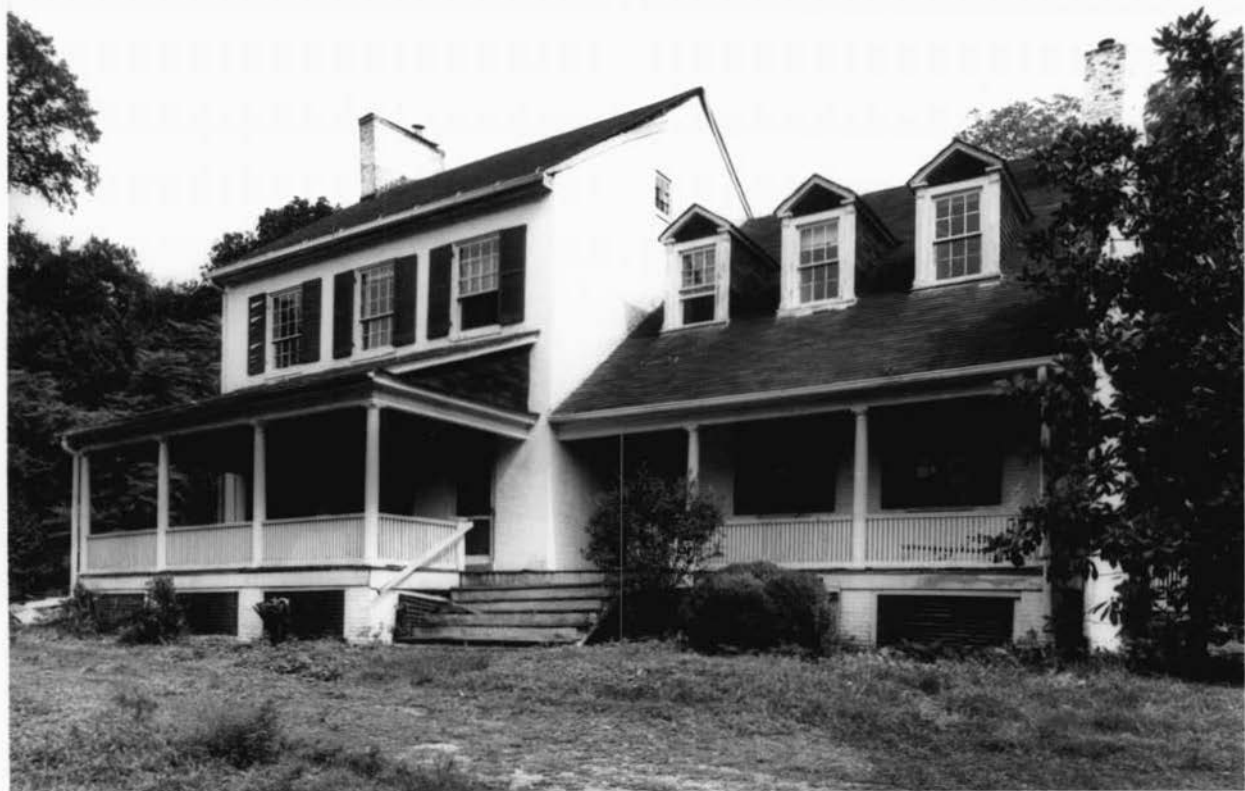
#1 OF 7

VIEW FROM SE

The Brick House on the Pike is sited atop a knoll facing south toward Baltimore National Pike. It is a large gable-roofed, brick dwelling, comprising three major periods of construction. In its present configuration, it comprises a two-story main block with a side-passage, double-pile plan; a  $1\frac{1}{2}$  story wing, two rooms deep, extends to the east. The south room of the present east wing appears to be the earliest portion, possibly dating from the mid-eighteenth century. This room measures approximately 26' wide by 17' deep, and likely stood as an independent structure, perhaps a  $1\frac{1}{2}$  story hall/parlor plan dwelling, when Caleb Dorsey acquired the property in the early 1770s. About 1817, the main block was added against the west gable of the earlier building; it is likely that the wing also was increased in depth at that time to provide a kitchen and service area. About 1907, the wing was raised in height, creating several bedrooms and a bath in the half-story, and a broad porch was added across the south facade.

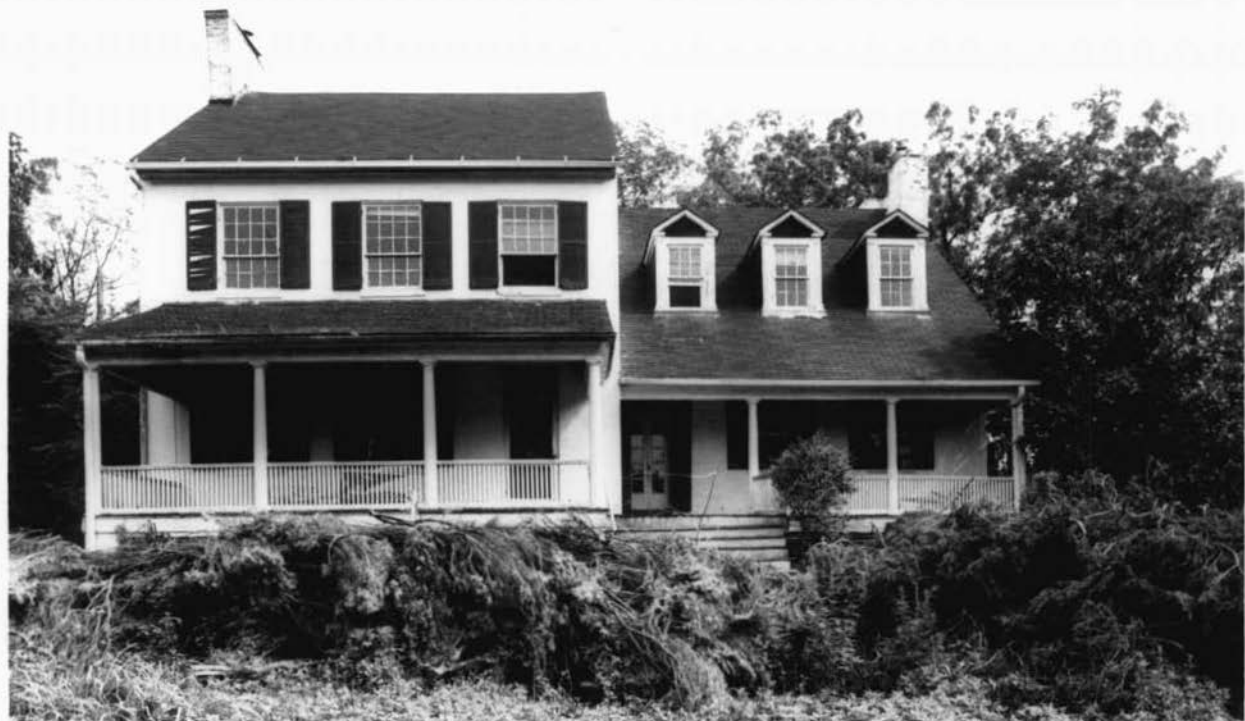
# 2 OF 7

SOUTH FACADE

The building is constructed of brick, which is uniformly painted white. The masonry of the south facade of both the main block and the wing is laid in Flemish bond; secondary elevations are laid in five-course common bond. The foundation is uncoursed rubble.

The south facade of the main block is three bays wide, with the principal entrance located in the easternmost bay. The entrance comprises a six-panel door in a paneled jamb. The panels have shallow fields and quarter-round cutouts at the corners, a familiar characteristic of the Federal style in the region. Panel molds have a cyma recta profile. The door is surmounted by a fanlight featuring exceptionally refined tracery executed in metal. The threshold is cut stone. The remaining ground-floor bays hold large 12/12 windows in openings with multi-coursed jack arches and cut stone sills. The upper story has three 12/12 windows, somewhat smaller than those below, with simple one-brick jack arches and cut stone sills. An elaborate gougework bed mold enriches the boxed cornice. The ground floor of the south facade is spanned by a broad porch resting on brick piers; Colonial Revival columns support the shed roof, which is enriched with a boxed cornice with bed and crown molds.

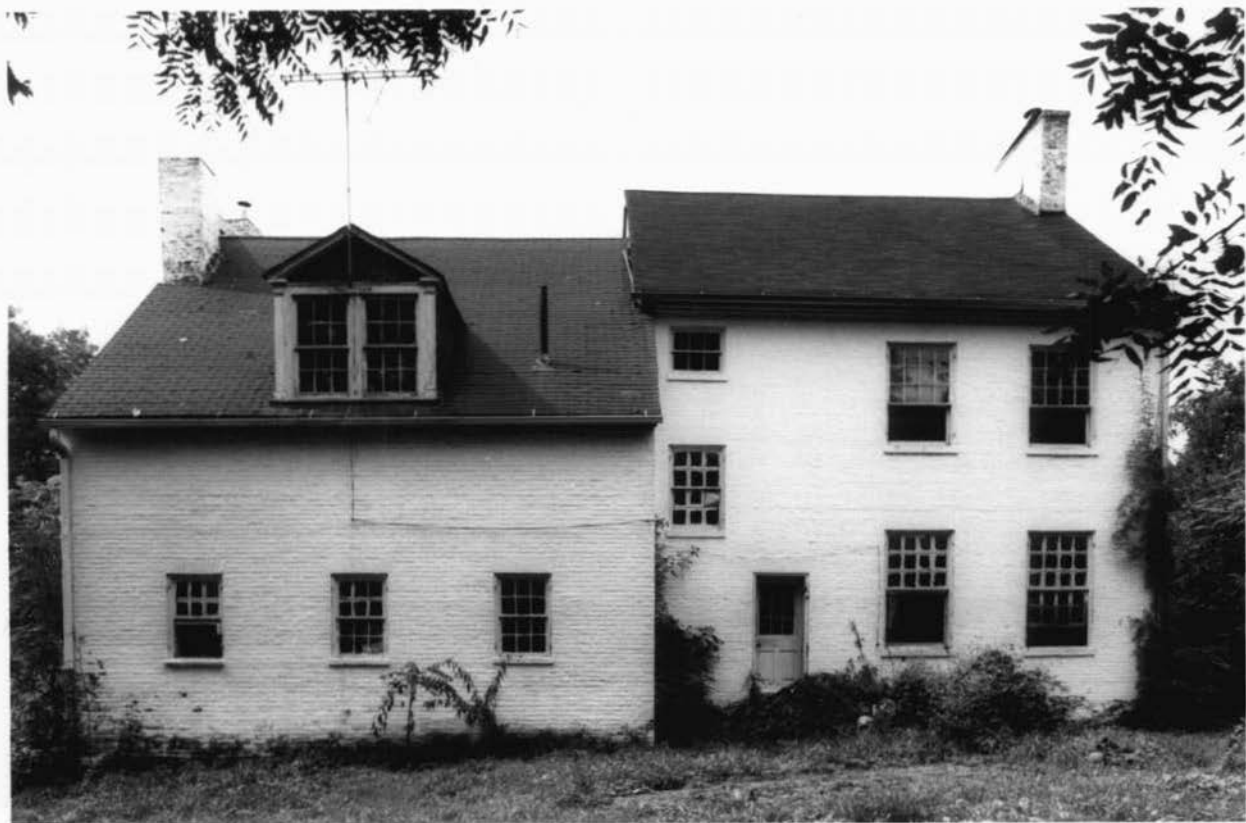
# 3 OF 7

NORTH ELEVATION

The north elevation of the main block is three bays wide, laid in five-course bond. There is an entrance in the east bay holding an unusual and apparently original door with two fielded panels below the lock rail and nine lights of glazing above. This door is set within a paneled jamb detailed in a manner similar to that of the front (south) entrance, but without the quarter-round cutouts in the corners of the panels. The remaining ground-floor bays (and the second-story bays above them) hold 12/12 sash in openings with single-brick jack arches and stone sills. The east bay has a 6/6 window at the level of the stair landing between the first and second stories, and a 3/3 sash at the landing between the second floor and the attic.

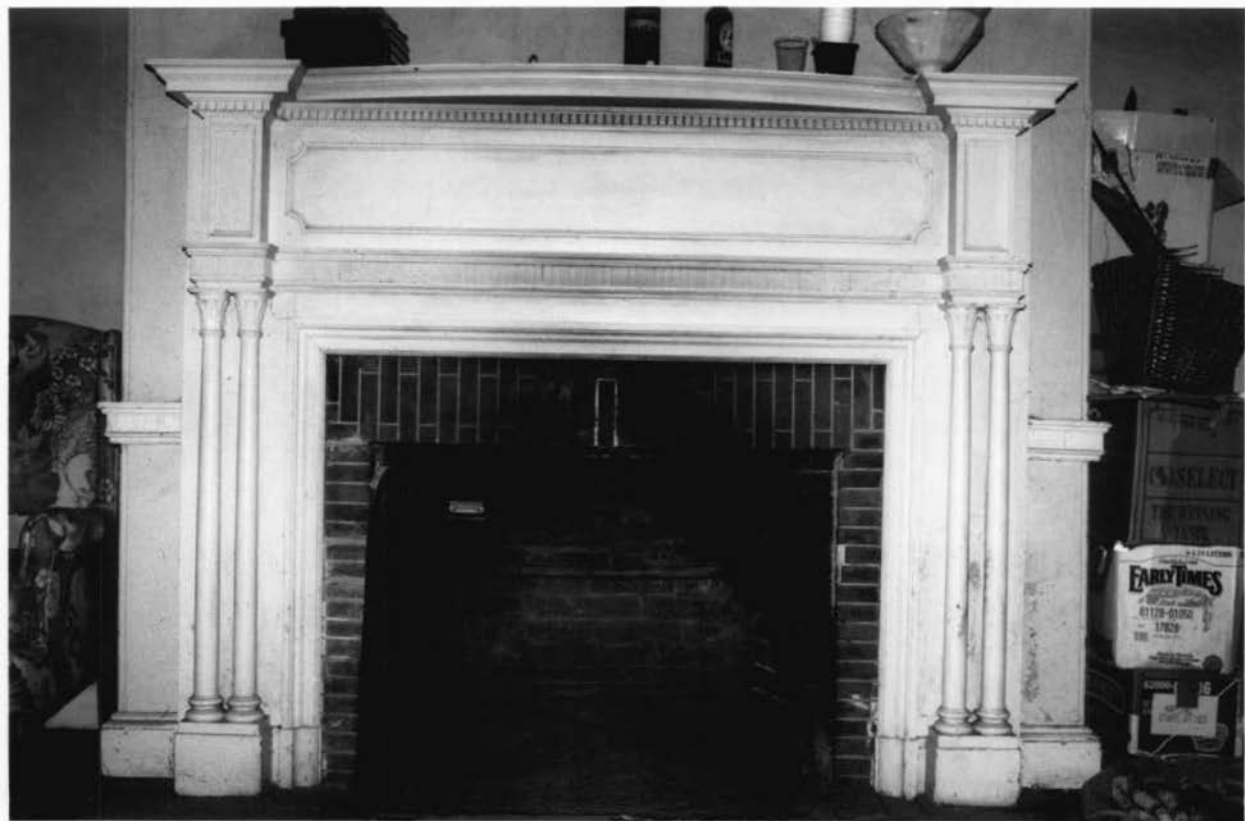
# 4 OF 7

MANTEL, SW ROOM

The southwest (front) room features decorative detailing comparable in quality and complexity to that of the stair passage. An elaborate molded plaster cornice, similar to that in the passage, encircles the ceiling. Six-panel doors have fielded panels with a cyma recta panel mold; they retain early hardware, including five-knuckle hinges and mortise locks. Architraves have a Greek ogee/astragal backband, broken field enriched with an ogee, and a torus at the edge; baseboards have Greek ogee/astragal caps; chair rail is identical to that in the passage. Windows are framed with paneled jambs, with panels below the sills. The focus of the room is an elaborate mantel on the west wall, featuring paired freestanding columns supporting paneled corner blocks and a bowed shelf. The columns have capitals with an abstracted foliate motif which is Egyptian in feeling. The edge of the shelf is treated with a cove/ogee molding; the bed molding is enriched with a row of dentils, with an ogee molding above and below. The frieze is decorated with applied molding, creating a rectangular panel with quarter-round cutout corners; a reeded band appears below the frieze. The fireplace opening is framed by cove/ovolo backband.

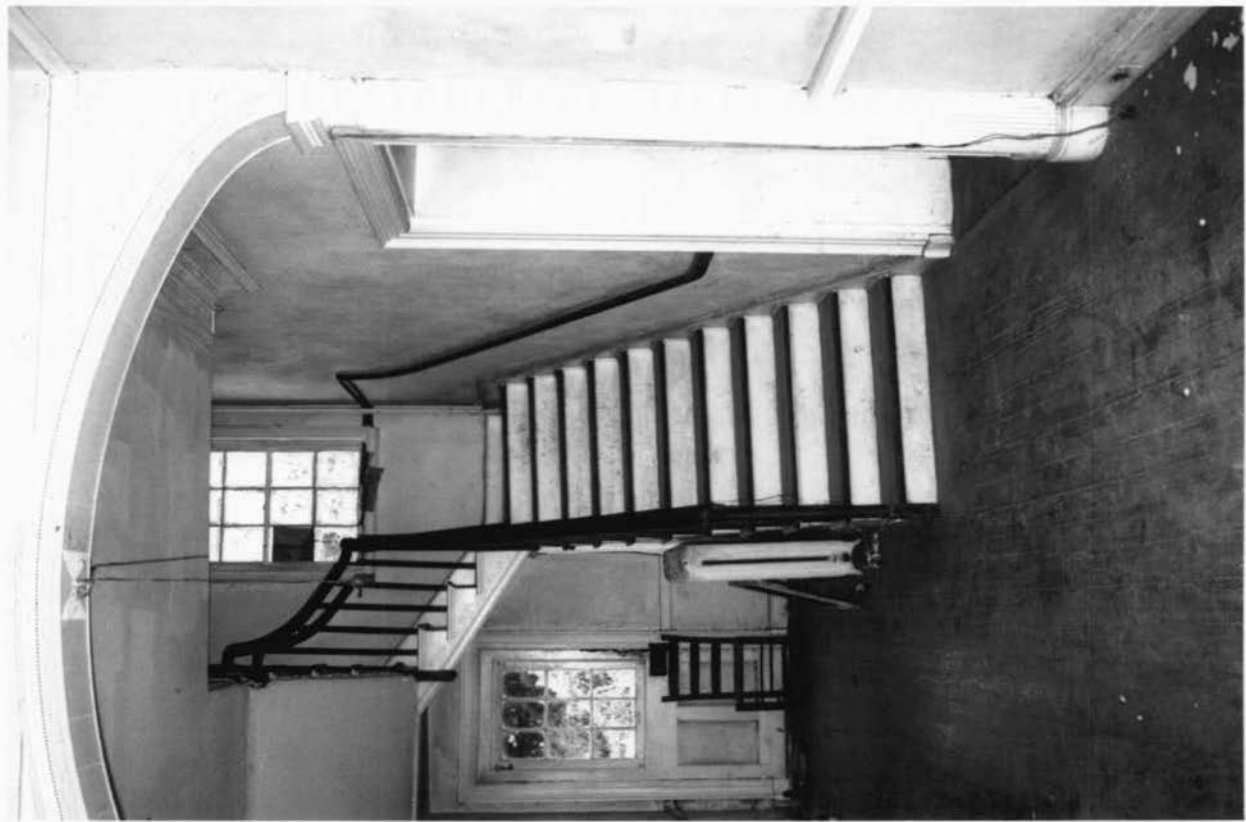
#5 OF 7

STAIR PASSAGE, VIEW FROM SOUTH

The south entrance opens into a formal stair passage which runs the full depth of the house. This space is richly detailed, with complex architrave, chair rail, and baseboard trim, a molded plaster cornice, and an outstanding central arch. The woodwork is exceptionally elaborate and well-crafted, and combines several molding profiles and elements associated with the Federal style. The architraves are enriched with a form of cove/astragal backband, a broken field with a small ogee at the transition, and a bold torus at the edge. The chair rail has an ogee/astragal shelf, a reeded field, and a Greek ogee/astragal base. Baseboards are capped with a cove molding above a torus. The central arch is supported on reeded columns; the column capitals and the fascia of the arch are detailed with punch- and gougework; the fascia is finished with a cove/astragal backband, and the soffit is reeded with a complex central panel. The three-flight, open-well stair rises against the east wall; it features a slender turned newel, rectangular balusters, and a mushroom-profile handrail (all of walnut or mahogany), scrolled step ends, and fielded paneling in the spandrel. A six-paneled door under the stair provides access to the basement.

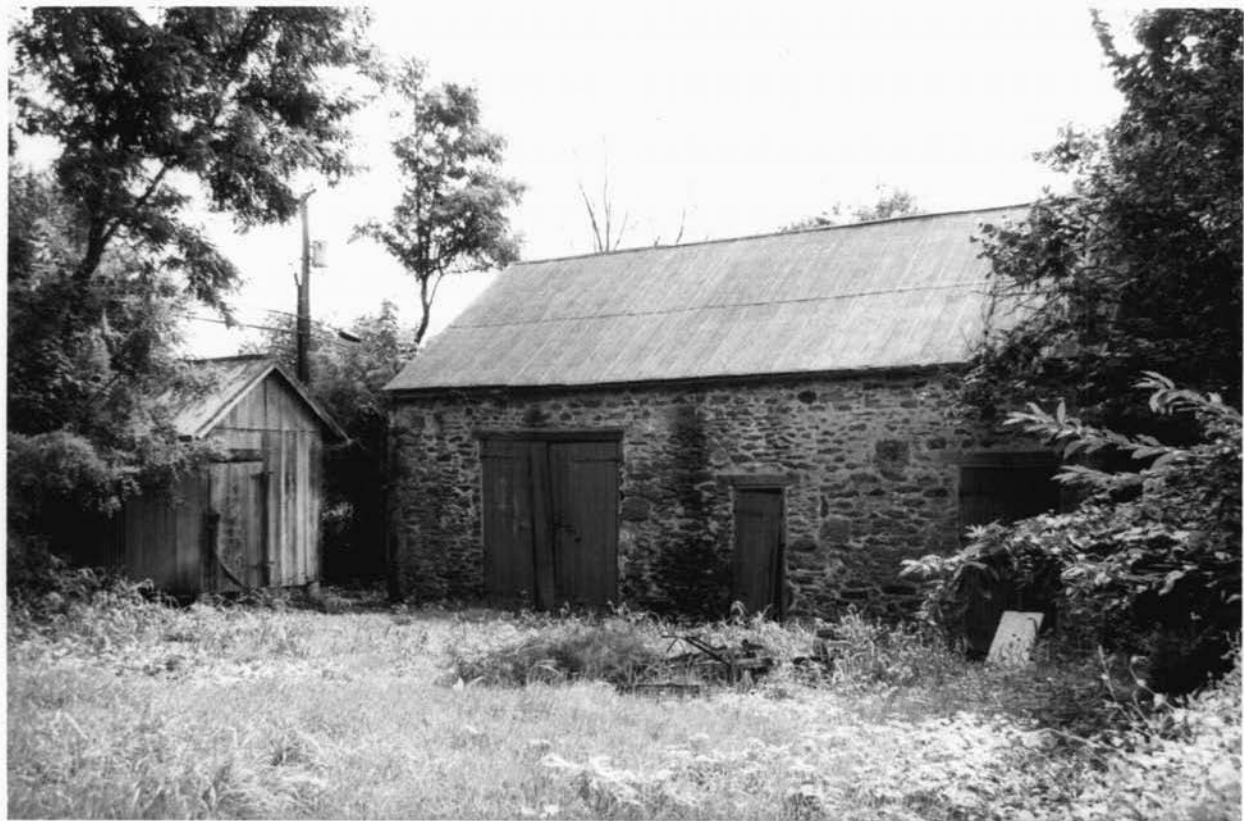
# 6 OF 7

STONE STABLE AND FRAME GRANARY / CORN CRIB  
VIEW FROM SW

The property retains several outbuildings, including a stone stable/carriage house located about 50 yards east of the dwelling; built of uncoursed rubble with prominent quoins, this building is probably contemporaneous with the house.

Three frame outbuildings of the late nineteenth or early twentieth century complete the grouping. Clad in circular-sawn board-and-batten siding secured with wire nails, these include a combination granary and corncrib adjacent to the stable, a garage or wagon shed near the northeast corner of the house, and a small gable-roofed shed northwest of the garage.

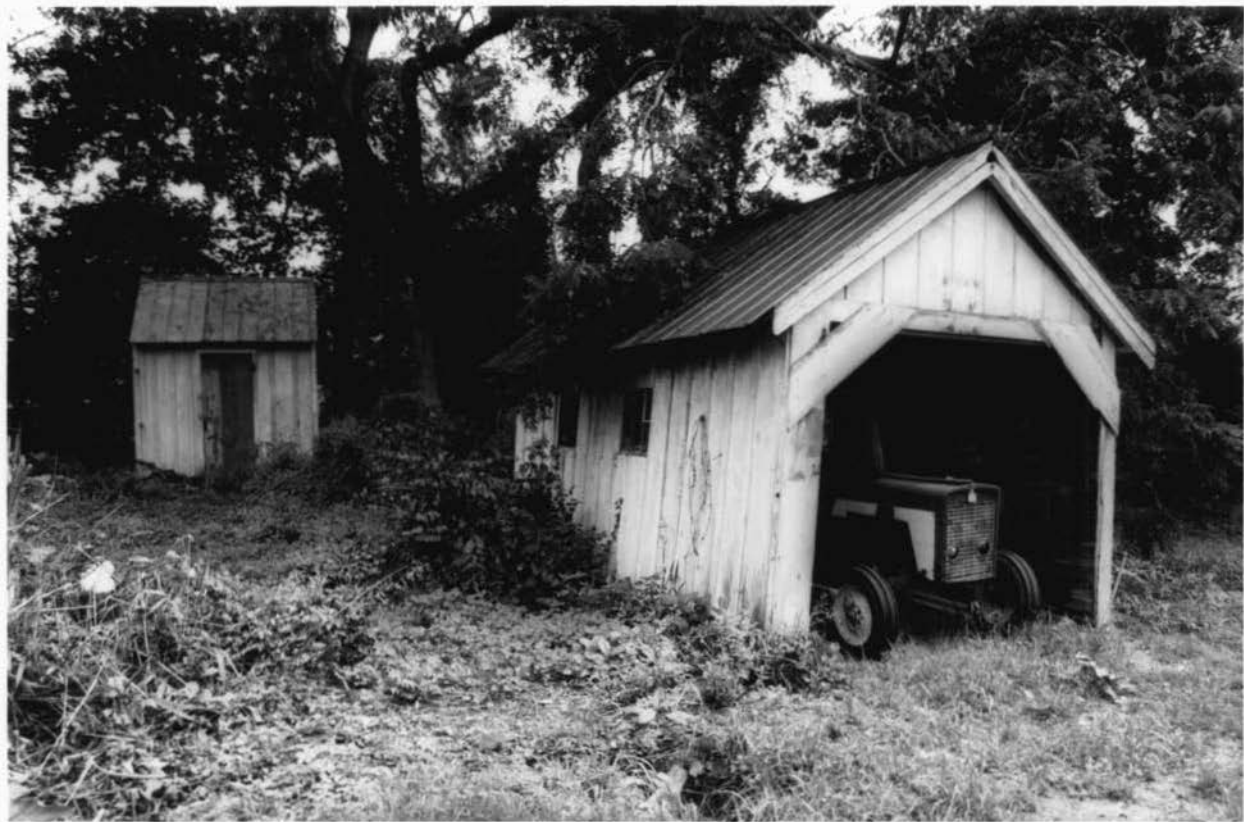
#7 of 7

OUTBUILDINGS, VIEW FROM S
